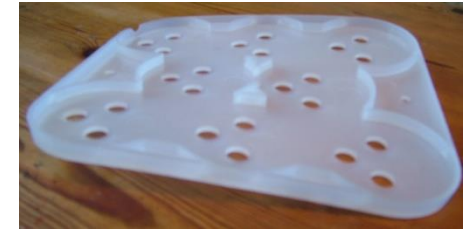
## Distortion/Warping

- Air Ejector Programs causing distortion
- Stacker/Packing causing distortion
- Wrong grade of material
- Coolant not circulating
- Melt temperature too low or too high
- Cooling time too short
- Holding pressure too low (mould under-packed)
- Holding time too short (mould under-packed)
- Mould being over-packed

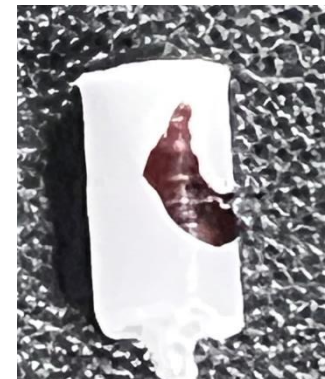
- Foreign bodies in raw material (lower pic)
- Contamination from feed lines & hopper
- Burnt material in the hopper
- Degraded plastic in barrel after standing
- Contamination around the nozzle tip
- Incompatible plastics mixed
- Poor storage of material

Degraded material from granulation process at polymer supplier (rare)

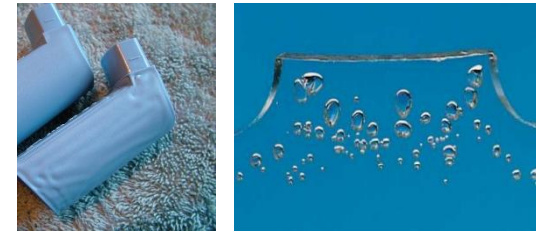
## Sinking & Voids Bubbles”\*

- Barrel Temps too high
- Injection speed too low
- Shot weight (feed) too small
- No cushion of material
- Wrong grade of plastic
- Mould too hot
- Holding time too short
- **Holding pressure too low**
- Switch-over too early
- Injection speed too low
- Injection pressure too low
- Back pressure too low
- Check ring not working

*\*Voids: this “Bubble” is not an air bubble! it’s an internal sink mark! Air in the melt shows as “silver streaks” on the surface, similar to Moisture / damp marks from undried polymers*

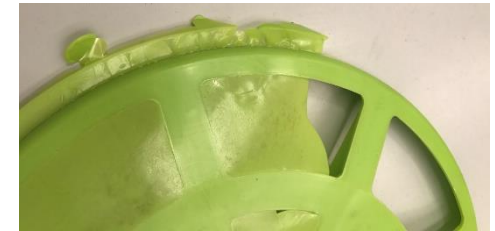
# FLASH

- Plastic temperature too high (*flowing too easily*)
- Plastic temperature too low (*solidifies too soon*)
- Shot weight (feed) too big
- Gate blocked on multi cavity mould
- Incorrect plastic being used (*flowing too easily*)
- Mould too hot
- Vents blocked
- Holding pressure too high
- Clamp force too low
- Mould height incorrectly set
- Mould faces damaged
- Switch-over too late
- Injection speed too fast
- Back pressure too high
- Machine not purged after standing
